Operation TEAPOT

Project 5.1

DESTRUCTIVE LOADS ON AIRCRAFT
IN FLIGHT

Issuance Date: January 31, 1958

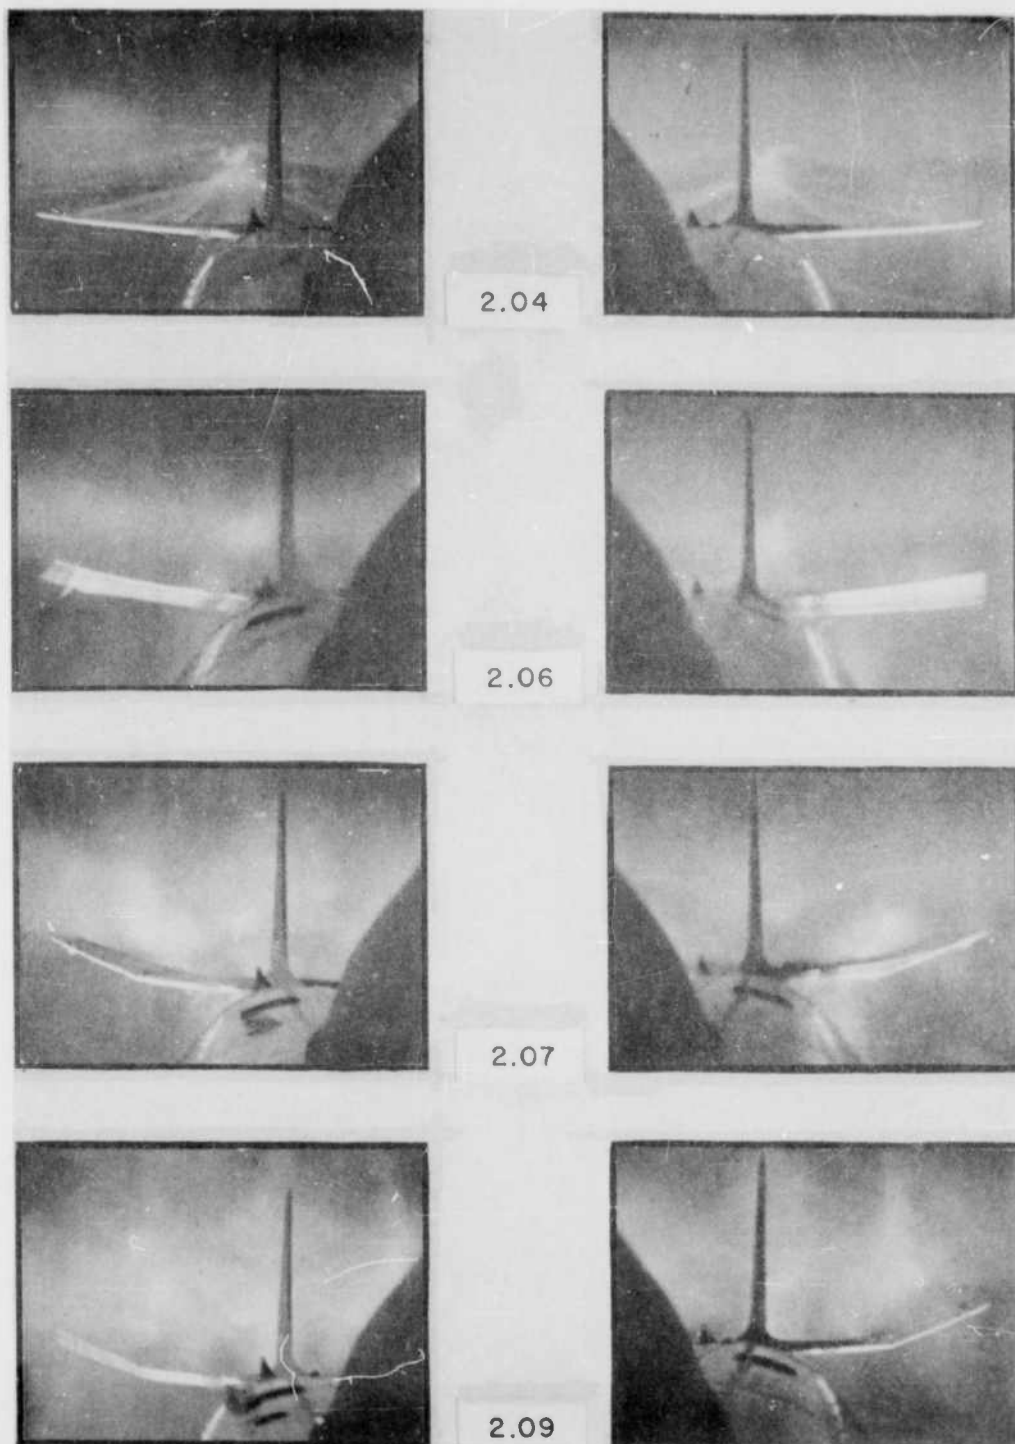
Figure 6.5 Horizontal Stabilizer Deflection at Shock Arrival, Drone 3. Numbers represent seconds after time zero.

An interesting photograph is shown in Figure 6.5, Sheet 1, at 2.07 seconds on the right side of the page. In this picture the camera caught two images of the left side of the horizontal stabilizer, one just before failure was reached and the other just after. Since the exposure time of
